Monongahela Dam 4 Spillway, Pennsylvania Hydraulic Model Investigation

by Deborah R. Cooper

Office of Management and Budget, Paperwork Reduction	on Project (0704-0186), Washington, D						
1. AGENCY USE ONLY (Leave blank)	2. REPORT DATE May 1997	3. REPORT TYPE A Final report	AND DATES COVERED

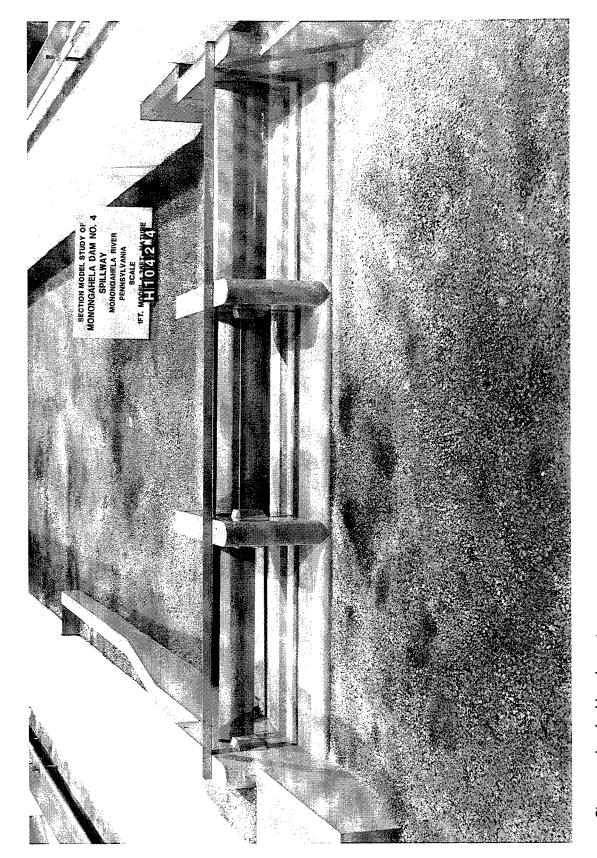
Figure 2. 1:36-scale model (Sheet 1 of 4)

a. Close-up view looking downstream

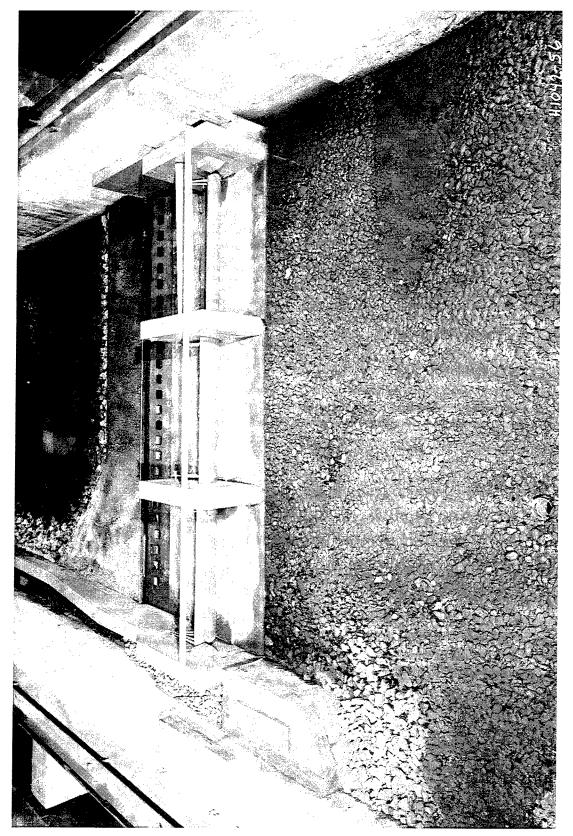
Figure 2. (Sheet 2 of 4)

b. Looking downstream

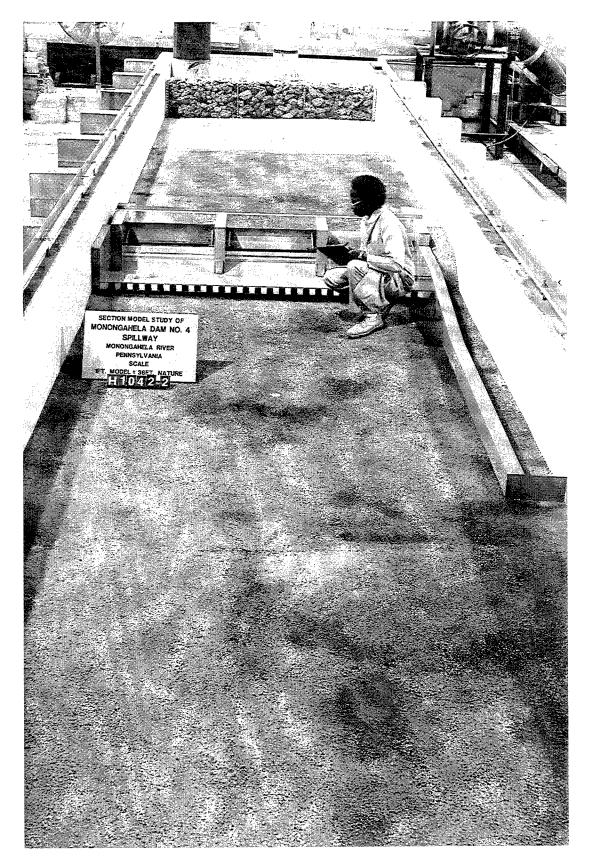
Figure 2. (Sheet 3 of 4)

c. Looking upstream

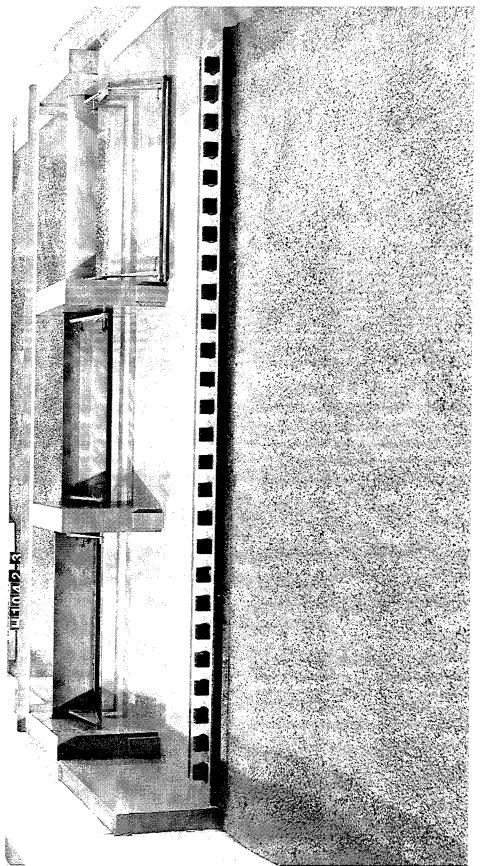
Figure 2. (Sheet 4 of 4)

d. Close-up view looking upstream

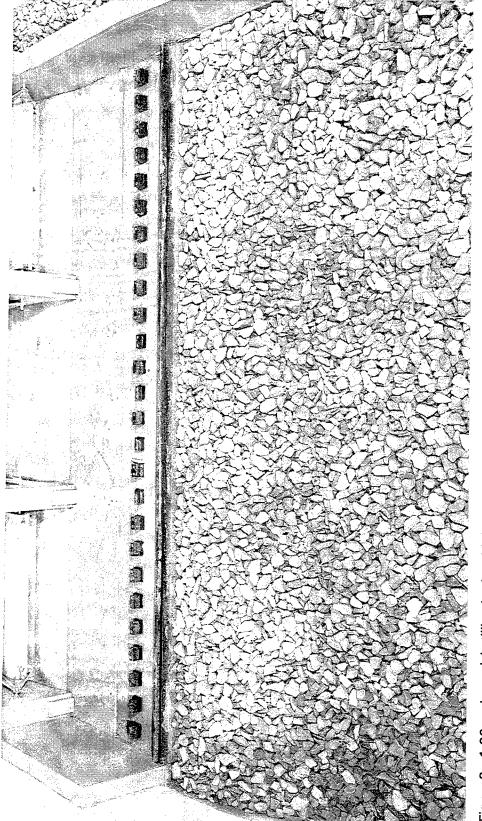
Figure 3. 1:36-scale model stilling basin with broken baffles, looking upstream

To simulate true prototype existing conditions, the baffles in the stilling basin were removed or broken to simulate missing and/or broken baffles based on a diver's inspection report provided by the Pittsburgh District (Appendix A, page A3). One piggyback and two radial tainter gates (gate bays 3-5) were investigated. Initially, an 8.8-m- (29-ft-) thick rock ledge simulating 0.9-m (3-ft) derrick stone was placed for 6.0 m (20 ft) immediately downstream of the end sill followed by a 9.1-m- (30-ft-) long, 1V on 2H, and a 29.6-m- (97-ft-) long, 1V on 13.85H derrick stone wedge as shown in Figures 3 and 4 and Plates 13 and 14. This was designated the type 1 (existing) stone protection. Gradation curves for the derrick stone used in the model are shown in Plate 15. Each of the steady-state conditions shown on page A4 (experiments 1-6) was run for 6 hours (prototype). The derrick stone was displaced in several locations downstream of the dam during experiments 1 and 4 indicating that the original design and 1967 reconstruction of the dam were inadequate.

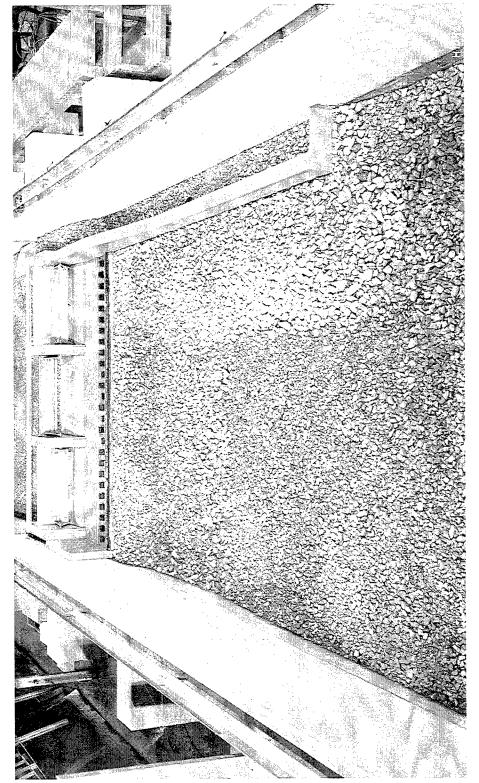
Figure 4. Type 1 (existing) derrick stone, looking upstream

Cursory experiments were conducted for proposed future pool conditions with the existing derrick stone protection to determine the impact of modifications to the stilling basin on the stability of the downstream protection. The top 0.6 m (2 ft) of the end sill was removed and the steady-state conditions shown on page A5 (experiments 1-6) were run for 6 hours (prototype). The stone failed again during experiments 1 and 4.

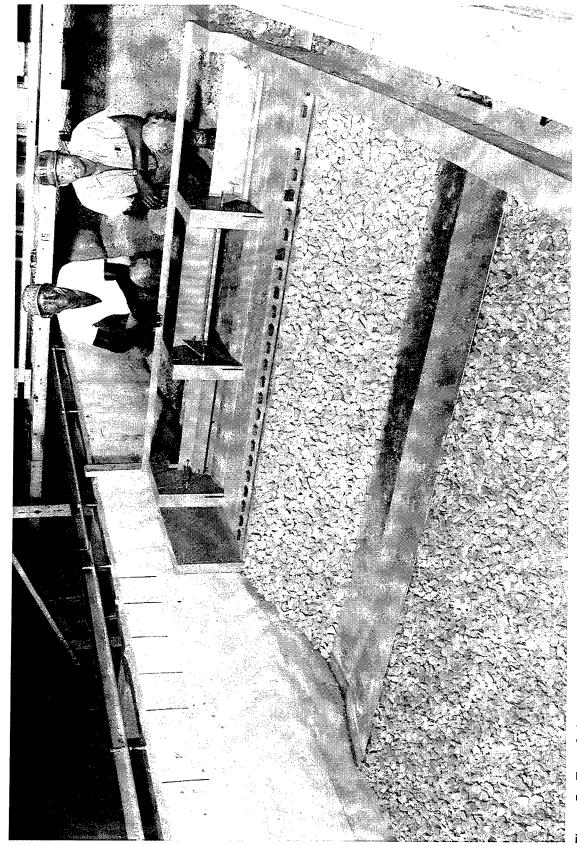
igure 5. Type 2 riprap protection, Configuration 1, looking upstream

The top 0.6 m (2 ft) of the end sill was reattached and a 2.6-m- (8.5-ft-) thick blanket simulating protective stone with a D_{50min} of 1 m (3.3 ft) (Class A) was installed in the model immediately downstream of the end sill as shown in Figure 5 and Plates 16 and 17. Gradation curves for the riprap used in the model are shown in Plate 18. The 2.6-m- (8.5-ft-) thick blanket simulating protective stone with a D_{50min} of 1 m (3.3 ft) was placed at 1V on 3H for 26.5 m (87 ft) downstream of the end sill as shown in Figure 5 and Plates 16 and 17. The riprap sloped from el 720.0 to el 691.0 (the top of soft rock). This was designated the type 2 design riprap protection plan. Each of the steady-state conditions shown on pages A6-A8 was run for 12 hours (prototype) for a factor of safety. The significance of each experiment with respect to the prototype can be found in the District-furnished material included in Appendix A. The riprap failed at the toe during single gate operation at gate openings of 1.8 m (6 ft), 2.4 m (8 ft), and fully open. Flow conditions for each experiment are shown in Photos 1-15. Results of riprap stability experiments are presented in Table 6. Increasing stone size at the toe of the slope did not eliminate the failures. Additional single gate experiments resulted in

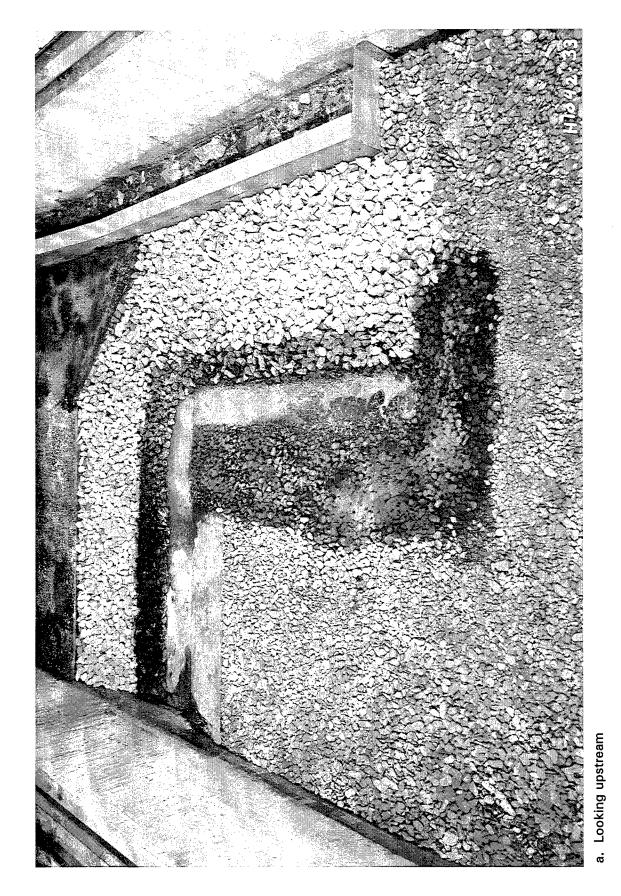
Figure 6. Type 3 riprap/rock apron protection (Continued)

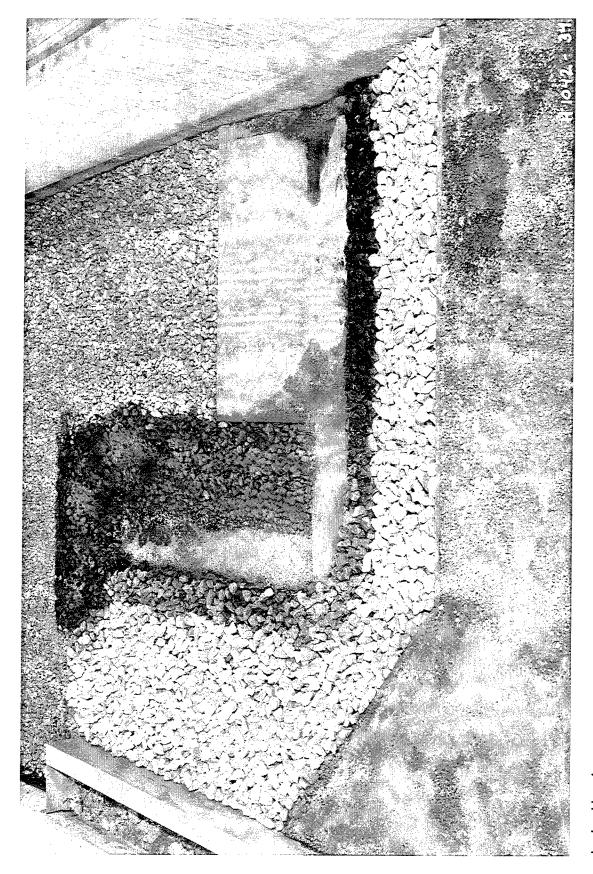
Figure 6. (Concluded)

b. Looking downstream

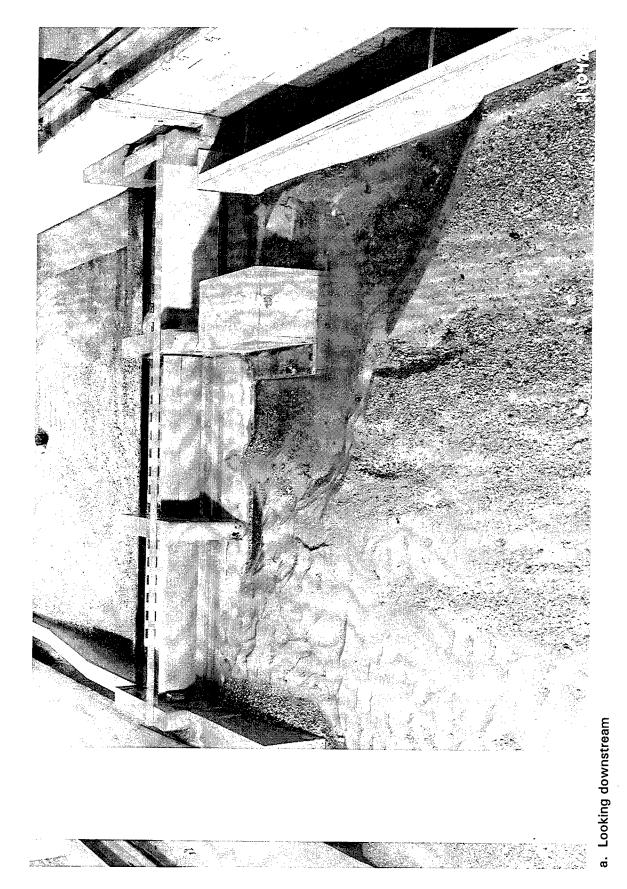
Figure 8. Type 1 (original) stub wall scour, 69 hours (Continued)

A 17.7-m- (58-ft-) wide and 17.1-m- (56-ft-) long stub wall was simulated in the model upstream of the dam along the lock wall as shown in Plate 51 and Figure 7. The Pittsburgh District engineers requested experiments to analyze the scour caused by the stub wall in the prototype. Each of the steady-state conditions in the tabulation on page A12 was run to simulate discrete discharges for a hydrograph provided by the Pittsburgh District. Soundings were measured in the model, and the resulting scour contours were plotted in

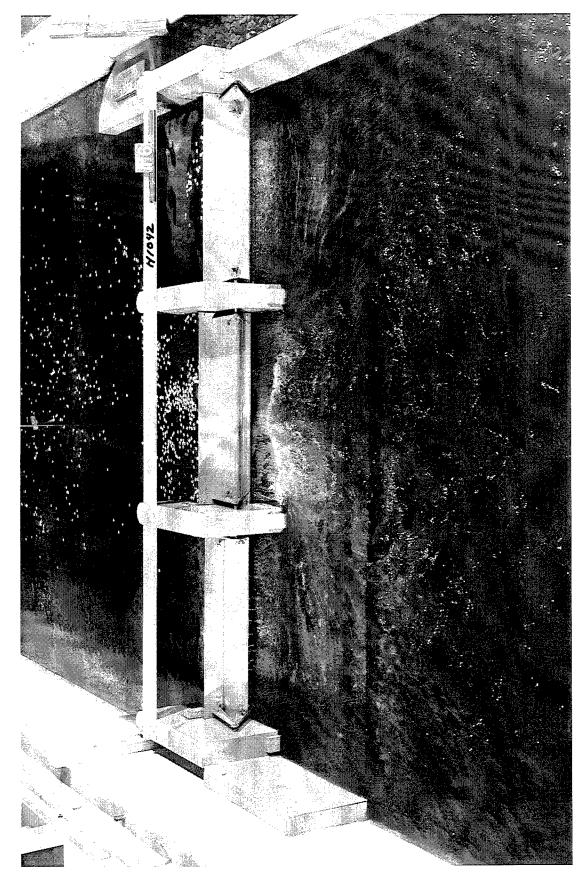
Photo 1. Type 2 riprap, configuration 1; Q = 129 cu m/sec (4,600 cfs); $G_2 = 0$, $G_3 = 0.6$ m (2 ft), $G_4 = 0$; pool el 743.5; tailwater el 730.6

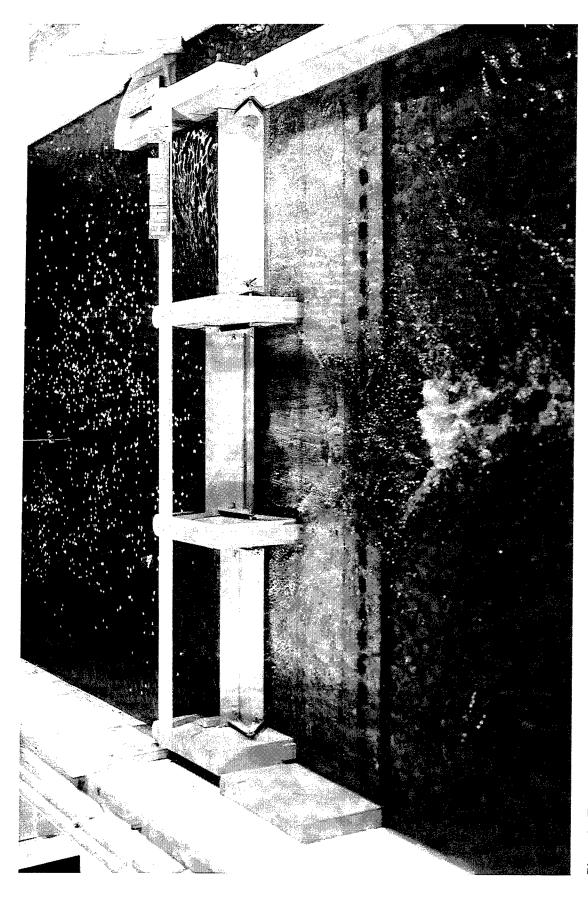
Photo 2. Type 2 riprap, Configuration 1; Q = 314 cu m/sec (11,200 cfs); $G_2 = 0$, $G_3 = 1.8$ m (6 ft), $G_4 = 0$; pool el 743.5; tailwater el 723.7

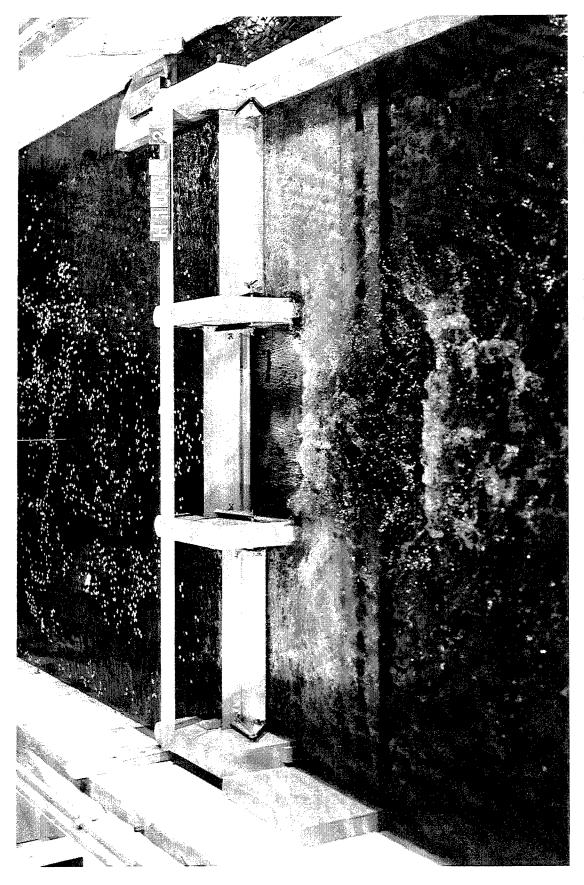
Photo 3. Type 2 riprap, Configuration 1; Q = 378 cu m/sec (13,500 cfs); $G_2 = 0$, $G_3 = 2.4$ m (8 ft), $G_4 = 0$; pool el 743.5; tailwater el 727.0

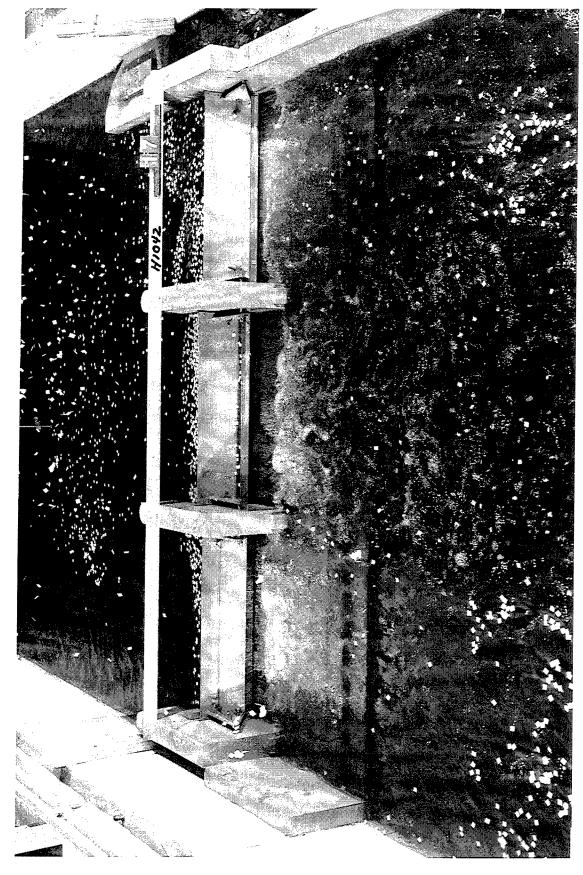
Photo 4. Type 2 riprap, Configuration 1; Q = 482 cu m/sec (17,200 cfs); $G_2 = 0.6$ m (2 ft), $G_3 = 1.2$ m (4 ft), $G_4 = 0.6$ m (2 ft); pool el 743.5; tallwater el 726.8

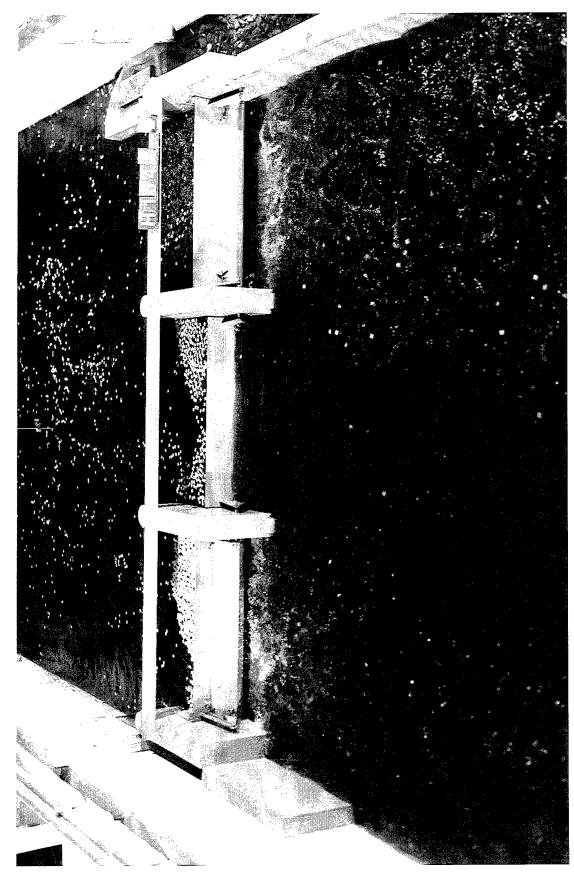
Photo 5. Type 2 riprap, Configuration 1; Q = 538 cu m/sec (19,200 cfs); $G_2 = 1.2$ m (4 ft), $G_3 = 0$, $G_4 = 1.8$ m (6 ft); pool el 743.5; tailwater el 728.9

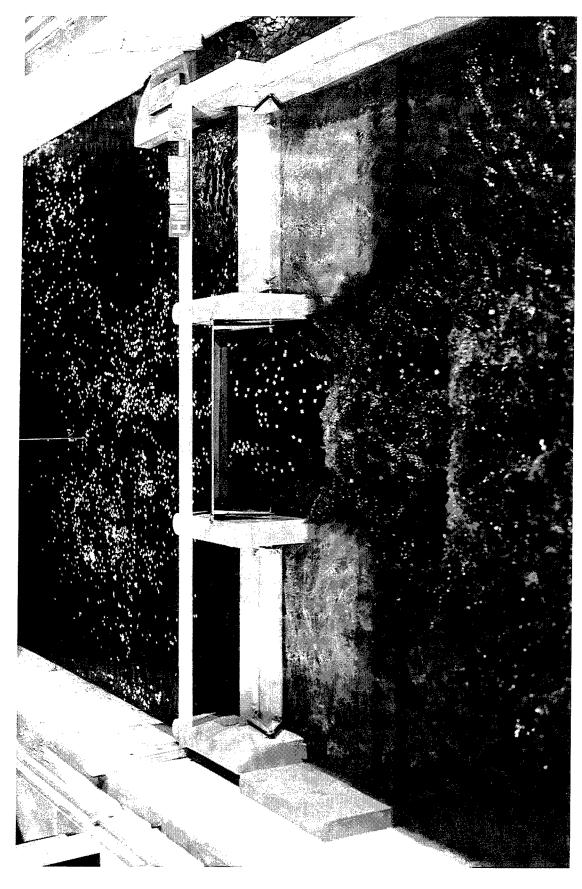
Photo 6. Type 2 riprap, Configuration 1; Q = 574 cu m/sec (20,500 cfs); $G_2 = 0$, $G_3 = \text{full}$, $G_4 = 0$; pool el 743.5; tailwater el 729.0

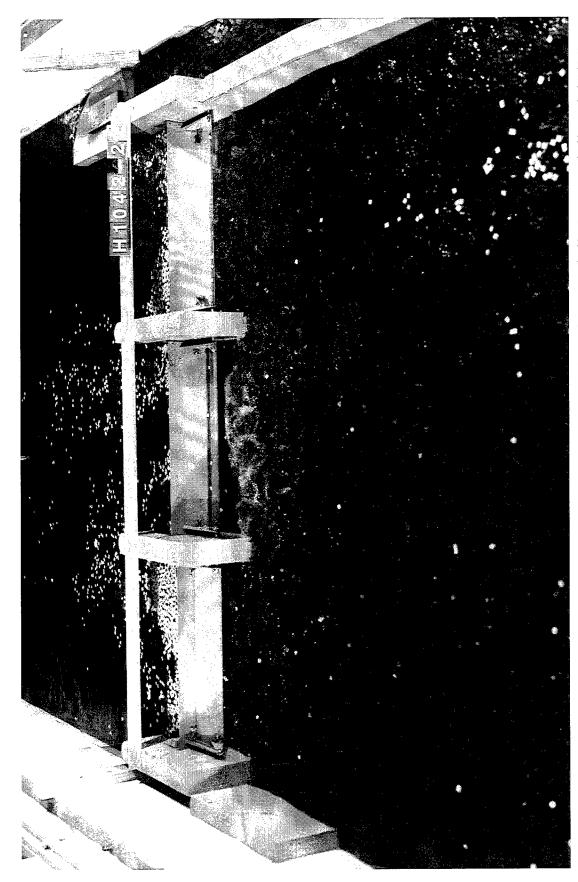
Photo 7. Type 2 riprap, Configuration 1; Q = 762 cu m/sec (27,200 cfs); $G_2 = 1.2$ m (4 ft), $G_3 = 1.8$ m (6 ft), $G_4 = 1.2$ m (4 ft); pool el 743.5; tailwater el 730.6

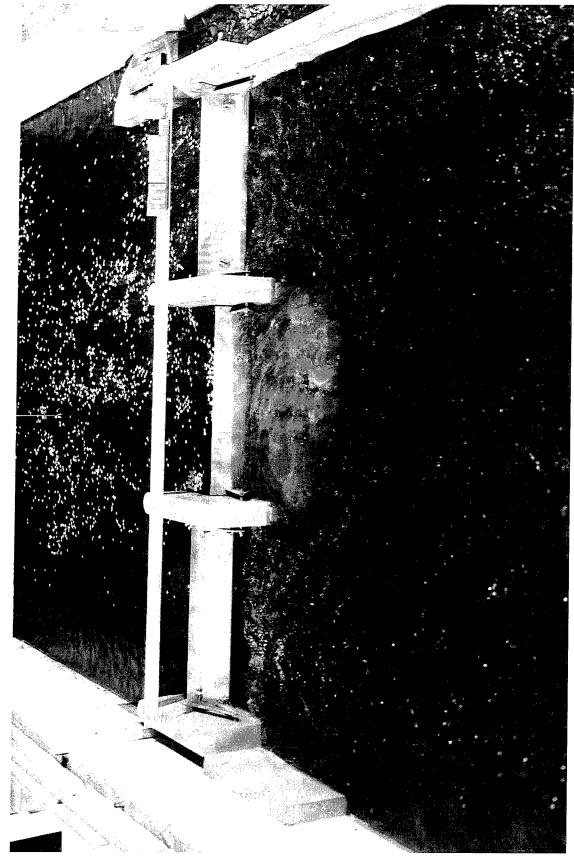
Photo 8. Type 2 riprap, Configuration 1; Q = 815 cu m/sec (29,100 cfs); $G_2 = 3.0$ m (10 ft), $G_3 = 0$, $G_4 = 2.4$ m (8 ft); pool el 743.5; tailwater el 733.1

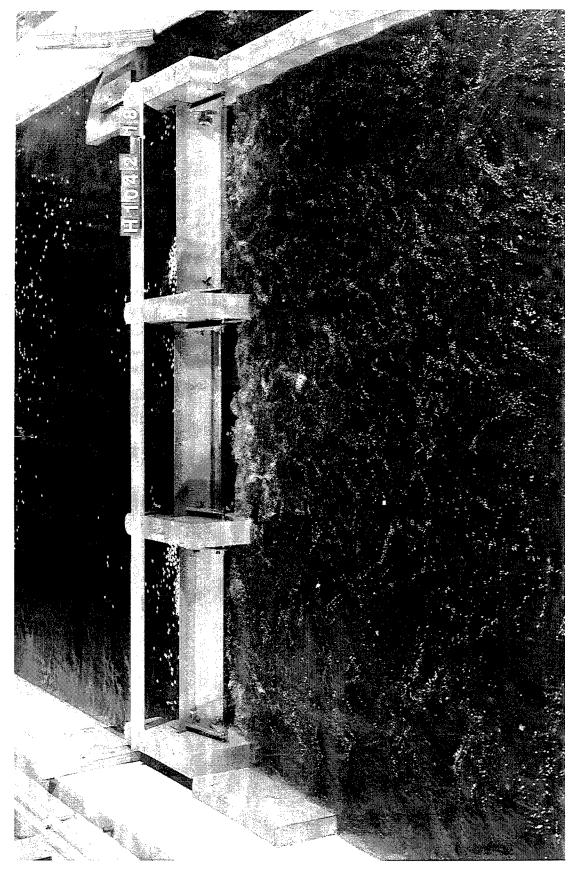
Photo 9. Type 2 riprap, Configuration 1; Q = 1,005 cu m/sec (35,900 cfs); $G_2 = 1.8$ m (6 ft), $G_3 = 2.4$ m (8 ft), $G_4 = 1.8$ m (6 ft); pool el 743.5; tailwater el 733.5

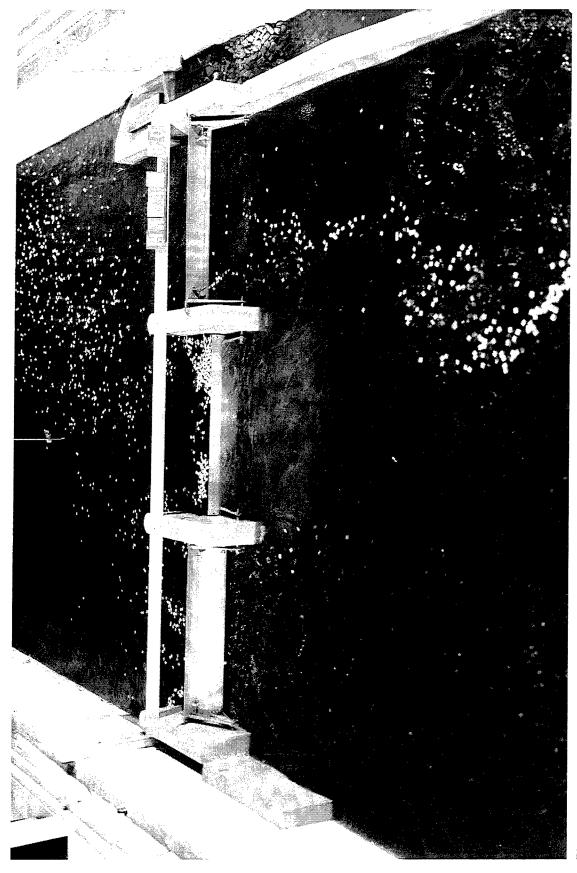
Photo 10. Type 2 riprap, Configuration 1; Q = 1,078 cu m/sec (38,500 cfs); $G_2 = 3.6$ m (12 ft), $G_3 = 0$, $G_4 =$ full; pool el 743.5; tailwater el 736.3

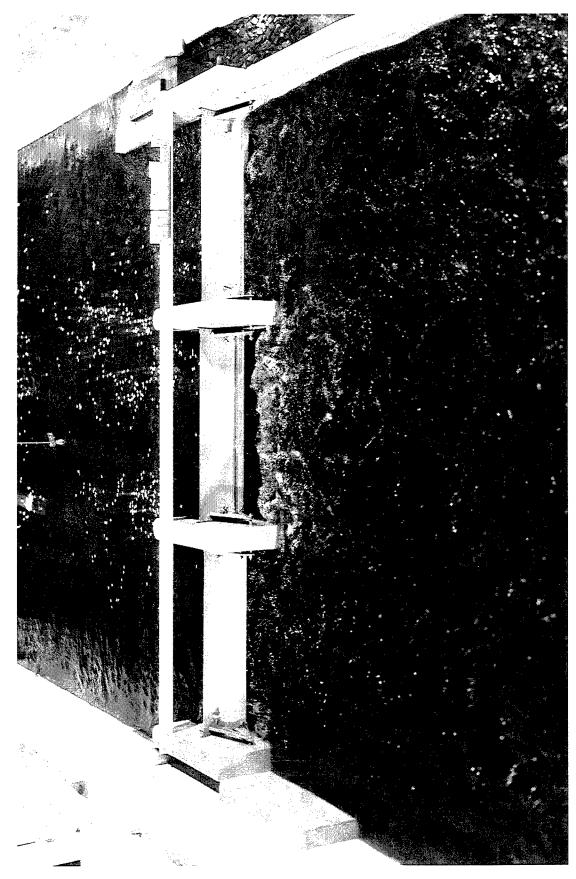
Photo 11. Type 2 riprap, Configuration 1; Q = 1,204 cu m/sec (42,600 cfs); $G_2 = 2.4$ m (8 ft), $G_3 = 3.0$ m (10 ft), $G_4 = 2.4$ m (8 ft); pool el 743.5; tailwater el 735.5

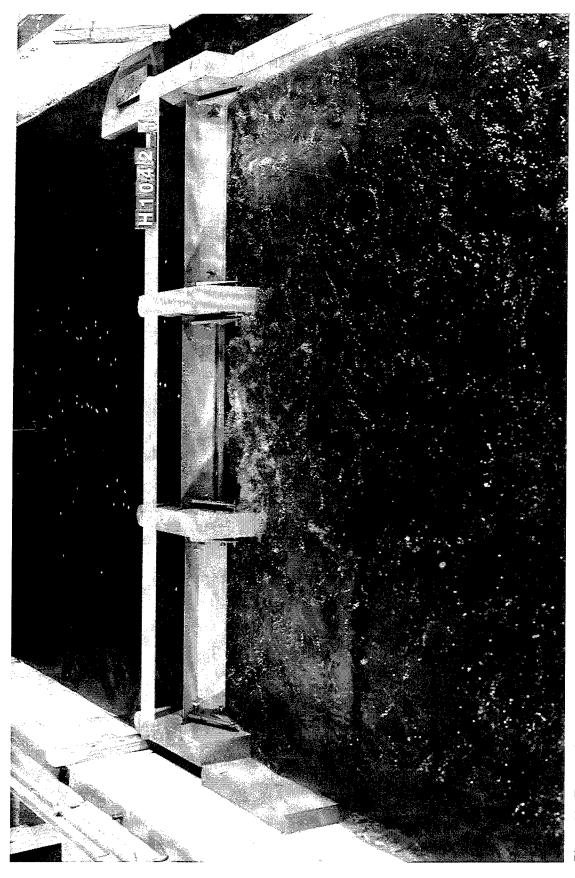
Photo 12. Type 2 riprap, Configuration 1; Q = 1,366 cu m/sec (48,800 cfs); $G_2 = 3.0$ m (10 ft), $G_3 = 3.6$ m (12 ft), $G_4 = 3.0$ m (10 ft); pool el 743.5; tailwater el 737.1

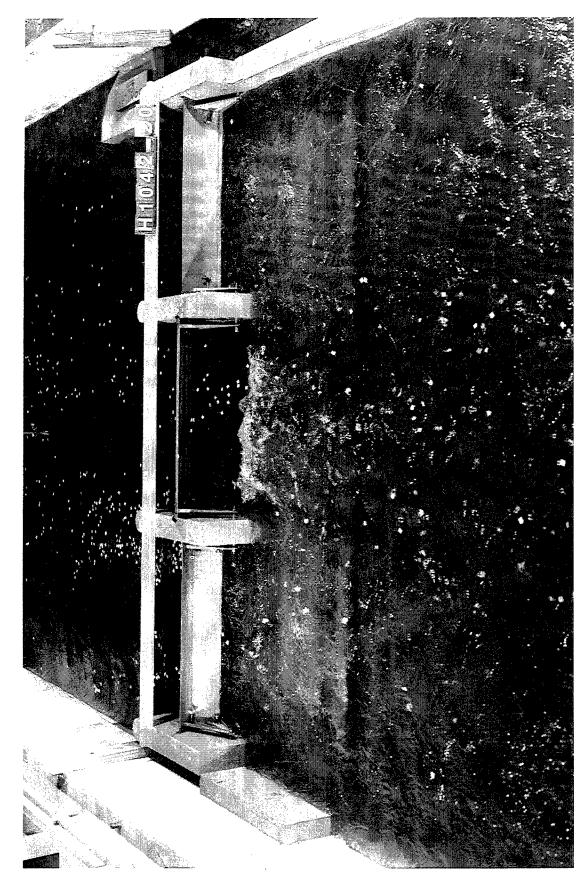
Photo 13. Type 2 riprap, Configuration 1; Q = 1,537 cu m/sec (54,900 cfs); $G_2 = 3.6$ m (12 ft), $G_3 = Full$, $G_4 = 3.6$ m (12 ft); pool el 743.5; tailwater el 739.0

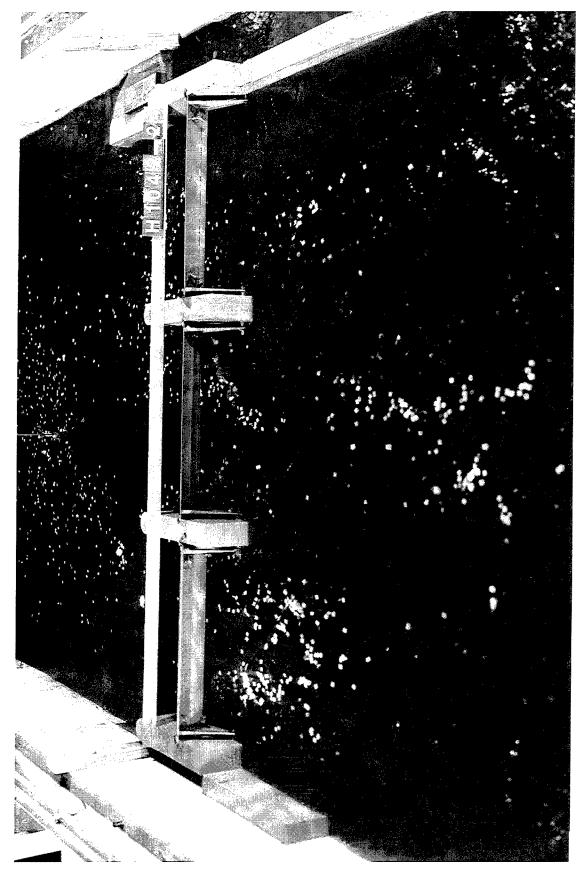
Photo 14. Type 2 riprap, Configuration 1; Q = 1,630 cu m/sec (58,200 cfs); $G_2 = \text{full}$, $G_3 = \text{full}$, $G_4 = \text{full}$; pool el 743.5; tailwater el 740.3

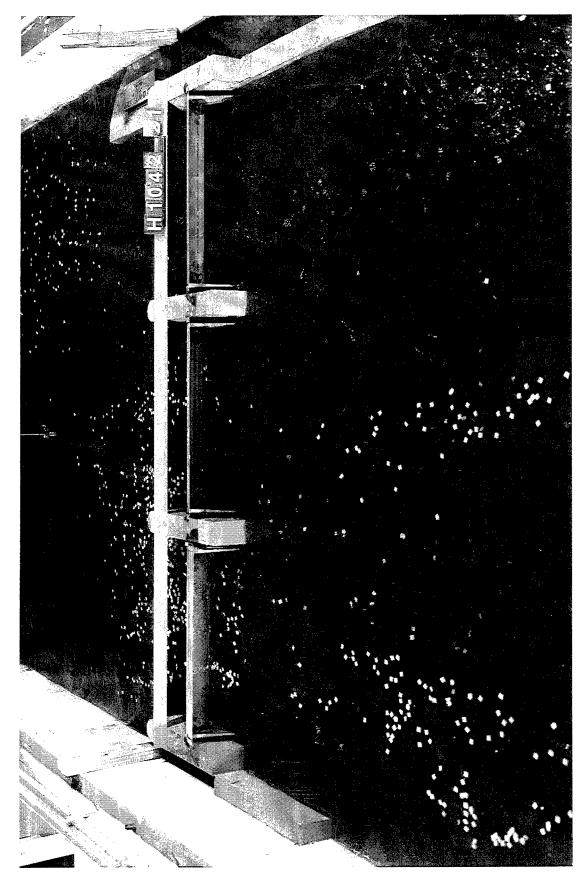
Photo 15. Type 2 riprap, Configuration 1; Q = 2,000 cu m/sec (73,800 cfs); $G_2 = \text{full}$, $G_3 = \text{full}$, $G_4 = \text{full}$; pool el 746.9; tailwater el 745.2

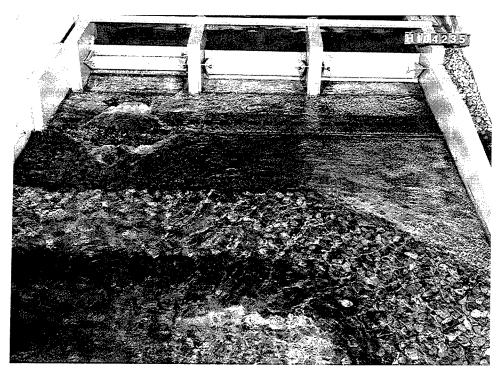
Photo 16. Type 3 riprap/rock apron, configuration 2; Q = 129 cu m/sec (4,600 cfs); G_3 = 0.6 m (2 ft), G_4 = 0, G_5 = 0; upper pool el 743.5; tailwater el 723.7

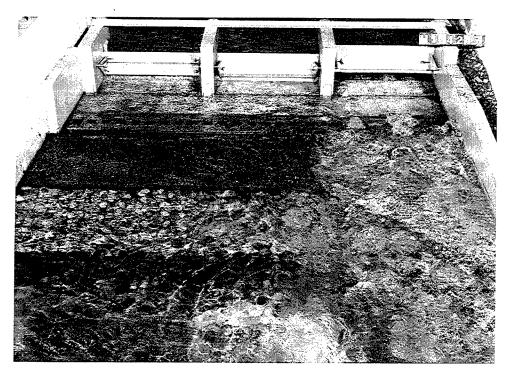
Photo 17. Type 3 riprap/rock apron, configuration 2; Q = 314 cu m/sec (11,200 cfs); $G_3 = 0$, $G_4 = 0$, $G_5 = 1.8$ m (6 ft); upper pool el 743.5; tailwater el 723.7

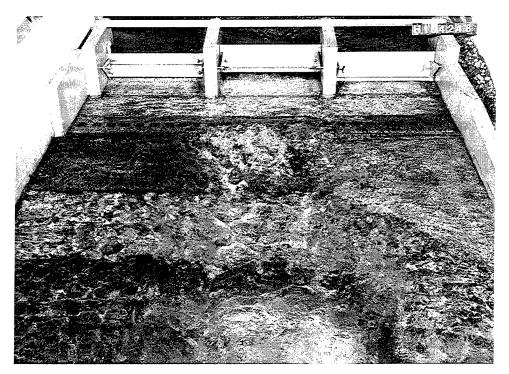
Photo 18. Type 3 riprap/rock apron, configuration 2; Q = 314 cu m/sec (11,200 cfs); G_3 = 0, G_4 = 1.8 m (6 ft), G_5 = 0; upper pool el 743.5; tailwater el 723.7

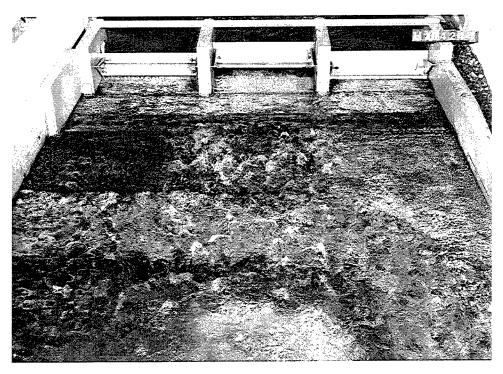
Photo 19. Type 3 riprap/rock apron, configuration 2; Q = 378 cu m/sec (13,500 cfs); G_3 = 0, G_4 = 2.4 m (8 ft), G_5 = 0; upper pool el 743.5; tailwater el 723.7

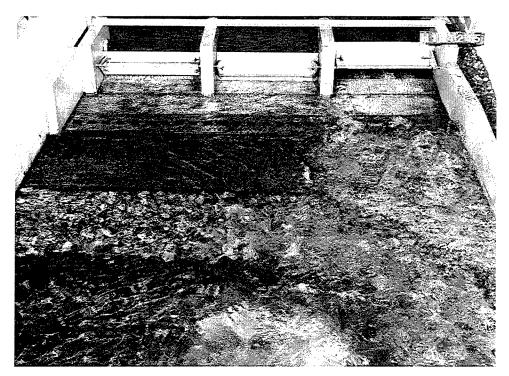
Photo 20. Type 3 riprap/rock apron, configuration 2; Q = 378 cu m/sec (13,500 cfs); G_3 = 0, G_4 = 0, G_5 = 2.4 m (8 ft); upper pool el 743.5; tailwater el 727.0

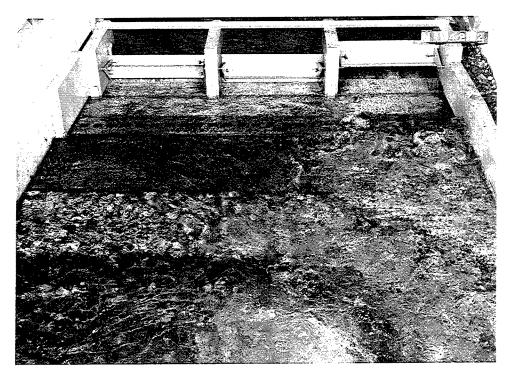
Photo 21. Type 3 riprap/rock apron, configuration 2; Q = 437 cu m/sec (15,600 cfs); G_3 = 0, G_4 = 0, G_5 = 3.0 m (10 ft); upper pool el 743.5; tailwater el 723.7

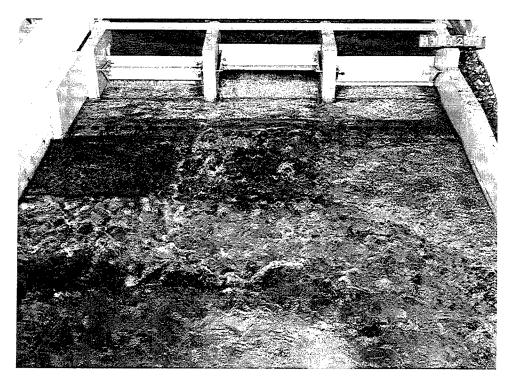
Photo 22. Type 3 riprap/rock apron, configuration 2; Q = 437 cu m/sec (15,600 cfs); G_3 = 0, G_4 = 3.0 m (10 ft), G_5 = 0; upper pool el 743.5; tailwater el 723.7

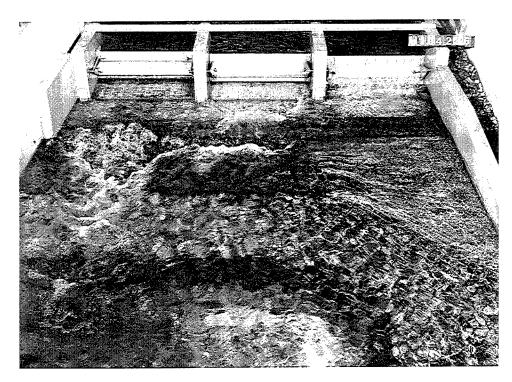
Photo 23. Type 3 riprap/rock apron, configuration 2; Q = 482 cu m/sec (17,200 cfs); G_3 = 1.2 m (4 ft), G_4 = 0.6 m, G_5 = 0.6 m (2 ft); upper pool el 743.5; tailwater el 726.8

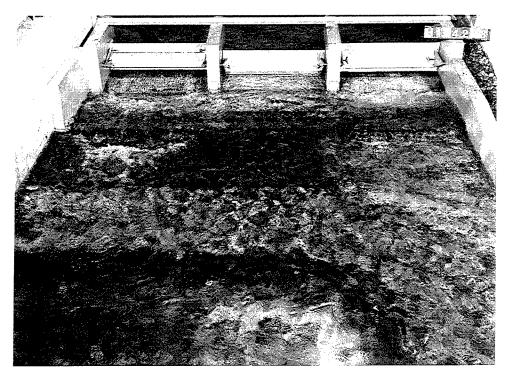
Photo 24. Type 3 riprap/rock apron, configuration 2; Q = 538 cu m/sec (19,200 cfs); G_3 = 1.8 m (6 ft), G_4 = 0, G_5 = 1.2 m (4 ft); upper pool el 743.5; tailwater el 728.9

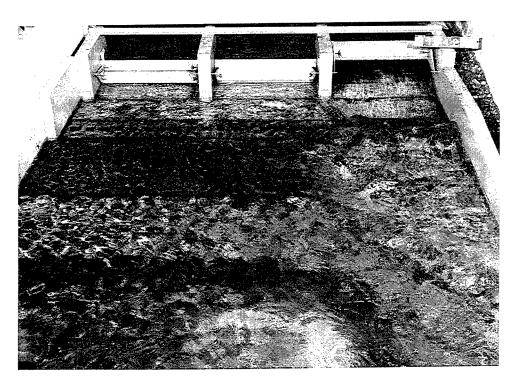
Photo 25. Type 3 riprap/rock apron, configuration 2; Q = 574 cu m/sec (20,500 cfs); G_3 = 0, G_4 = 0, G_5 = full; upper pool el 743.5; tailwater el 729.0

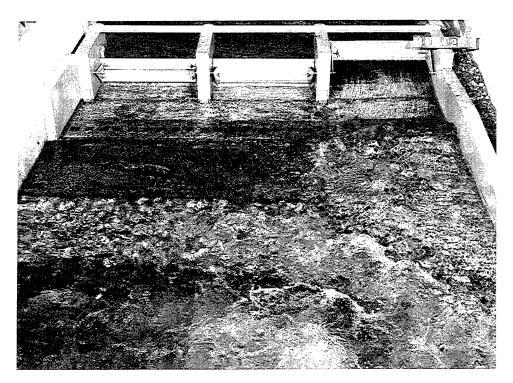
Photo 26. Type 3 riprap/rock apron, configuration 2; Q = 574 cu m/sec (20,500 cfs); G_3 = 0, G_4 = 0, G_5 = full; upper pool el 743.5; tailwater el 723.7

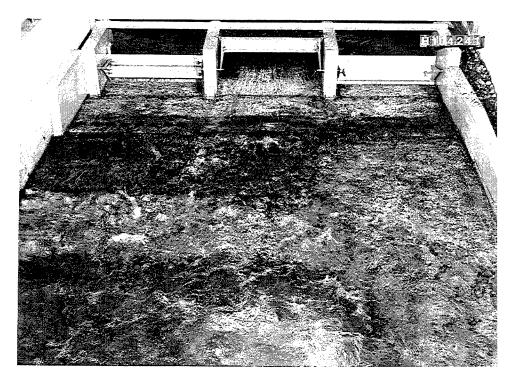
Photo 27. Type 3 riprap/rock apron, configuration 2; Q = 574 cu m/sec (20,500 cfs); G_3 = 0, G_4 = full, G_5 = 0; upper pool el 743.5; tailwater el 723.7

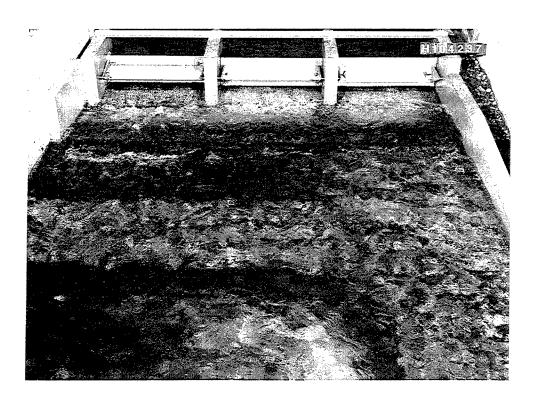
Photo 28. Type 3 riprap/rock apron, configuration 2; Q = 762 cu m/sec (27,200 cfs); G_3 = 1.8 m (6 ft), G_4 = 1.2 m (4 ft), G_5 = 1.2 m; upper pool el 743.5; tailwater el 730.6

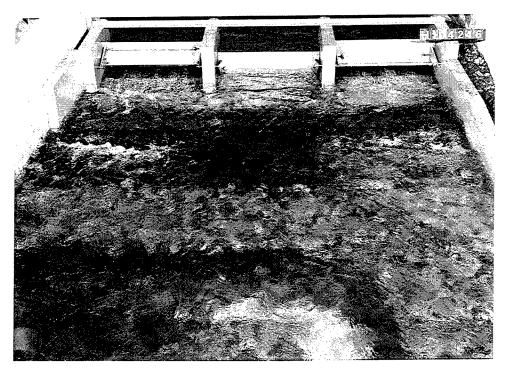
Photo 29. Type 3 riprap/rock apron, configuration 2; Q = 815 cu m/sec (29,100 cfs); G_3 = 3.0 (10 ft), G_4 = 0, G_5 = 2.4 m (8 ft); upper pool el 743.5; tailwater el 733.1

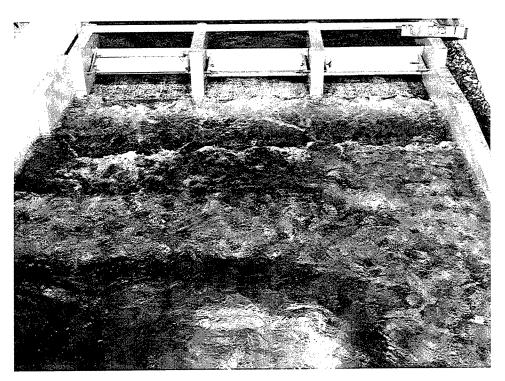
Photo 30. Type 3 riprap/rock apron, configuration 2; Q = 1,005 cu m/sec (35,900 cfs); G_3 = 2.4 m (8 ft), G_4 = 1.8 m (6 ft), G_5 = 1.8 m; upper pool el 743.5; tailwater el 733.5

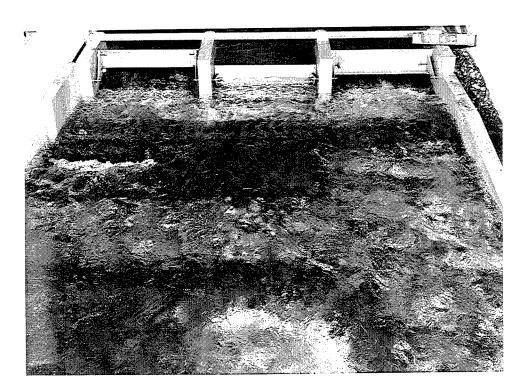
Photo 31. Type 3 riprap/rock apron, configuration 2; Q = 1,078 cu m/sec (38,500 cfs); $G_3 = \text{full}$, $G_4 = 0$, $G_5 = 3.6$ m (12 ft); upper pool el 743.5; tailwater el 736.3

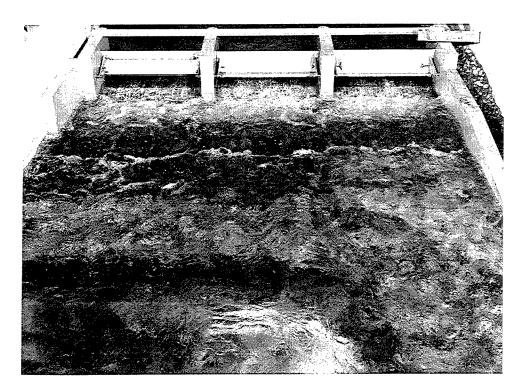
Photo 32. Type 3 riprap/rock apron, configuration 2; Q = 1,193 cu m/sec (42,600 cfs); G_3 = 3.0 m (10 ft), G_4 = 2.4 m (8 ft), G_5 = 2.4 m; upper pool el 743.5; tailwater el 735.5

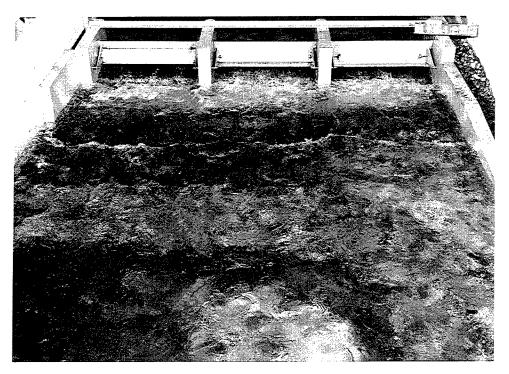
Photo 33. Type 3 riprap/rock apron, configuration 2; Q = 1,366 cu m/sec (48,800 cfs); G_3 = 3.6 m (12 ft), G_4 = 3.0 m (10 ft), G_5 = 3.0 m (10 ft); upper pool el 743.5; tailwater el 737.1

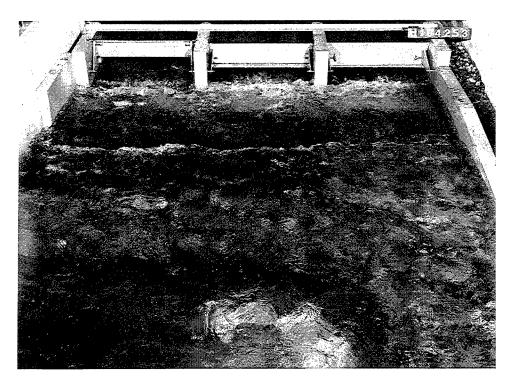
Photo 34. Type 3 riprap/rock apron, configuration 2; Q = 1,537 cu m/sec (54,900 cfs); G_3 = full, G_4 = 3.6 m (12 ft) , G_5 = 3.6 m (12 ft); upper pool el 743.5; tailwater el 739.0

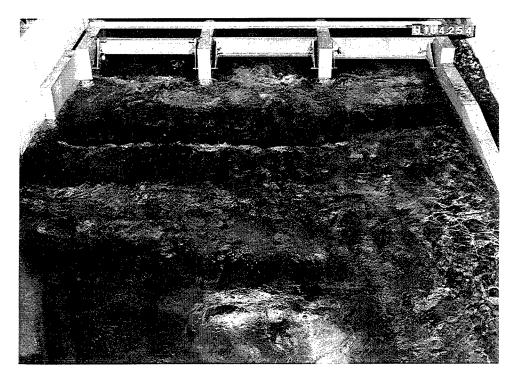
Photo 35. Type 3 riprap/rock apron, configuration 2; Q = 2,066 cu m/sec (73,800 cfs); G_3 = full, G_4 = full, G_5 = full; upper pool el 746.9; tailwater el 745.2

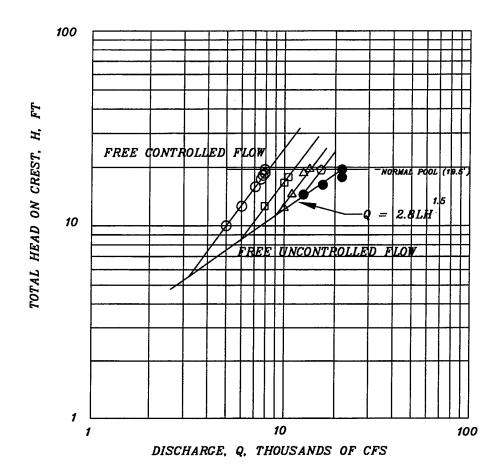
DISCHARGE-HEAD RELATIONSHIP FOR FREE FLOW CREST ELEVATION 724.0

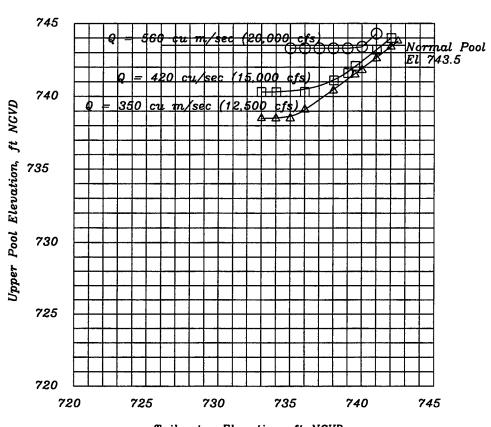
CALIBRATION DATA FOR UNCONTROLLED FLOW CREST ELEVATION 724.0

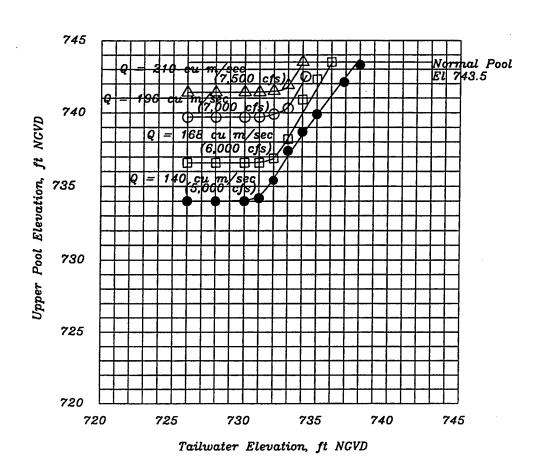
CALIBRATION DATA FOR CONTROLLED FLOW CREST ELEVATION 724.0 GATE OPENING 1.2 M (4.0 FT)

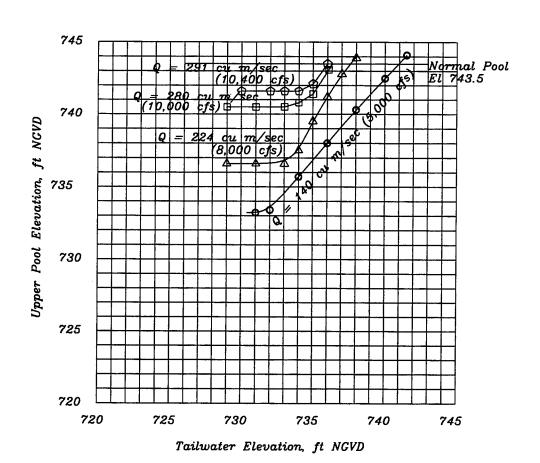
CALIBRATION DATA
FOR CONTROLLED FLOW
CREST ELEVATION 724.0
GATE OPENING 1.8 M (6.0 FT)

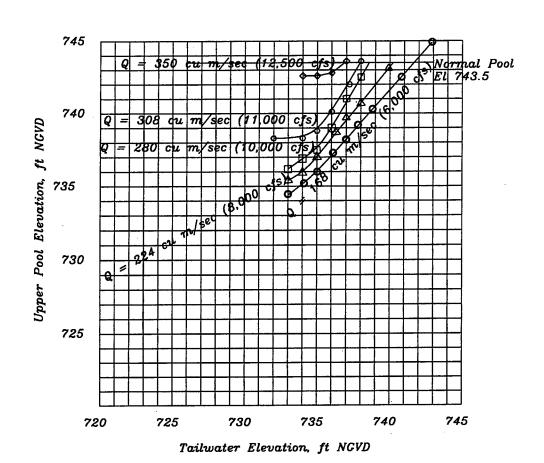
CALIBRATION DATA
FOR CONTROLLED FLOW
CREST ELEVATION 724.0
GATE OPENING 2.4 M (8.0 FT)

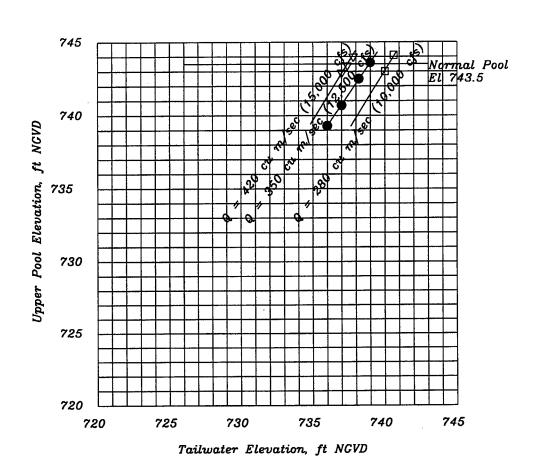
CALIBRATION DATA FOR CONTROLLED FLOW CREST ELEVATION 724.0 GATE OPENING 3.0 M (10.0 FT)

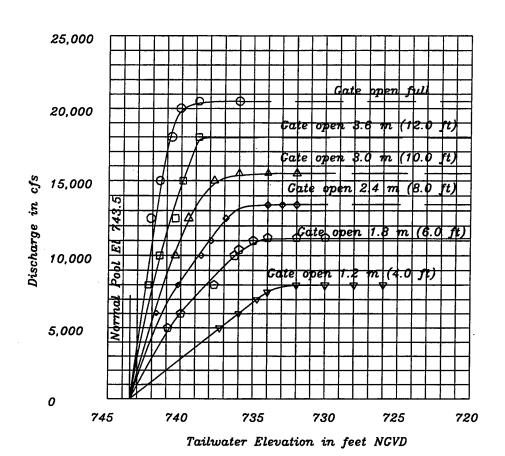
TAILWATER EFFECT ON DISCHARGE CREST ELEVATION 724.0 POOL ELEVATION 743.5

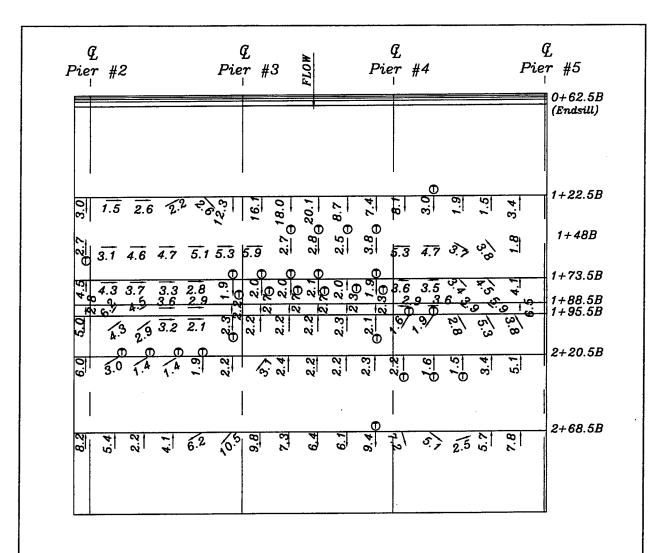
BOTTOM VELOCITIES

TYPE 3 RIPRAP/ROCK APRON

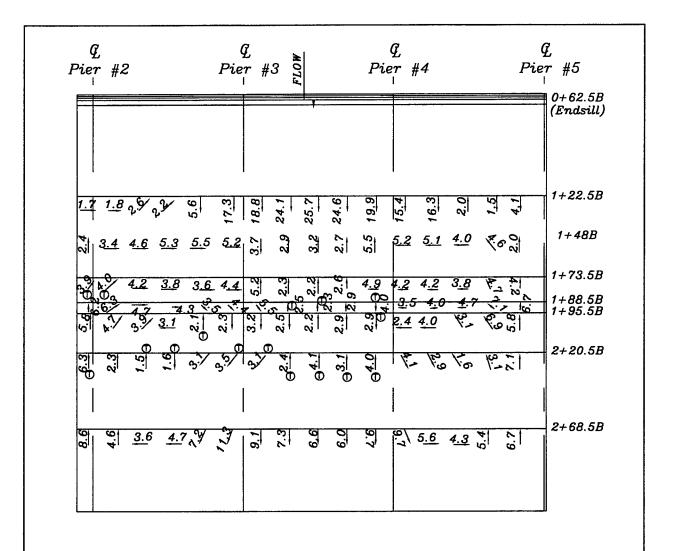
BOTTOM VELOCITIES TYPE 3 RIPRAP/ROCK APRON CONFIGURATION 1 Q = 378 CU M/SEC (13,500 CFS) $G_2 = 0$ ft, $G_3 = 2.4$ m (8 ft), $G_4 = 0$ ft

POOL EL 743.5, TW EL 723.7

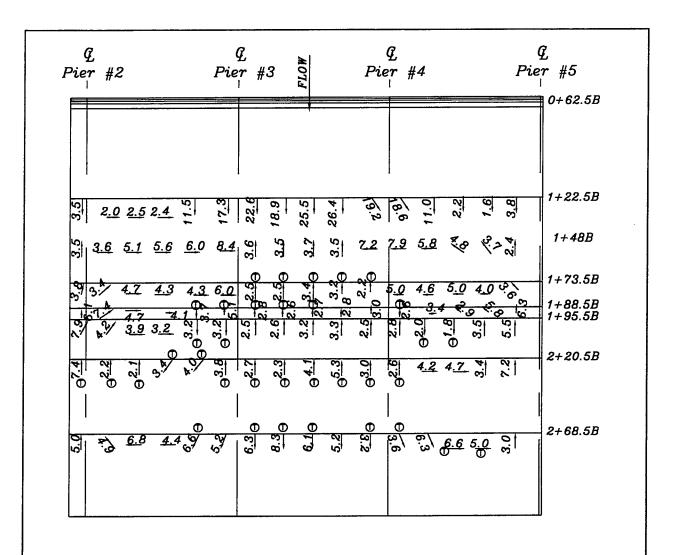
BOTTOM VELOCITIES

TYPE 3 RIPRAP/ROCK APRON CONFIGURATION 1 Q = 437 CU M/SEC (15,600 CFS) $G_2 = 0 \text{ ft, } G_3 = 3.0 \text{ m (10 ft), } G_4 = 0 \text{ ft}$ POOL EL 743.5, TW EL 723.7

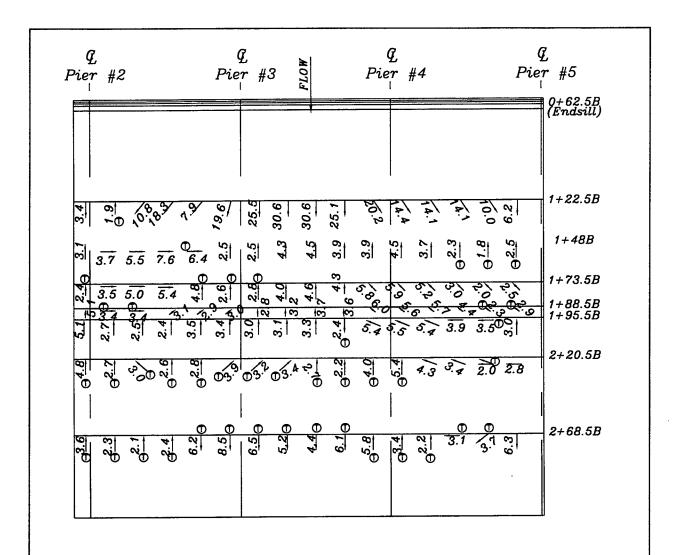
BOTTOM VELOCITIES

TYPE 3 RIPRAP/ROCK APRON CONFIGURATION 1

Q = 574 CU M/SEC (20,500 CFS) $G_2 = 0$ ft, $G_3 = FULL$, $G_4 = 0$ ft

POOL EL 743.5, TW EL 723.7

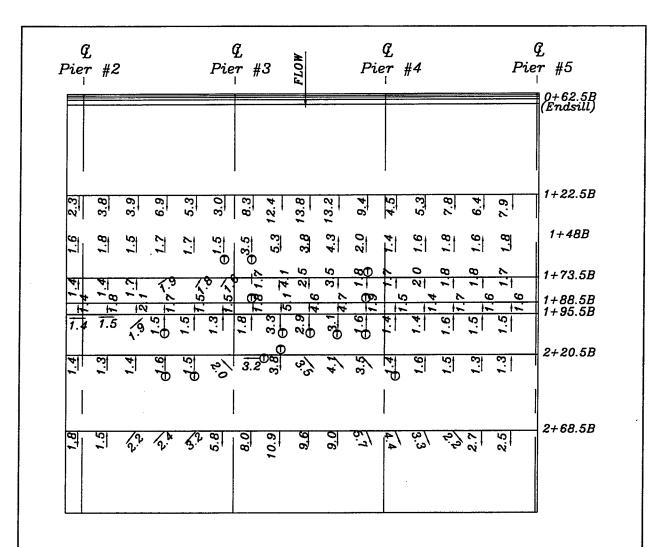
Note: Lateral spacing is 5.5 m (18 ft).

① = Turbulence
